## DIGNITY RENEWED IN THE PARLOR

What we found behind the drywall helped us restore a focal point. **By Derek Gjerde and Allison Hoffman**

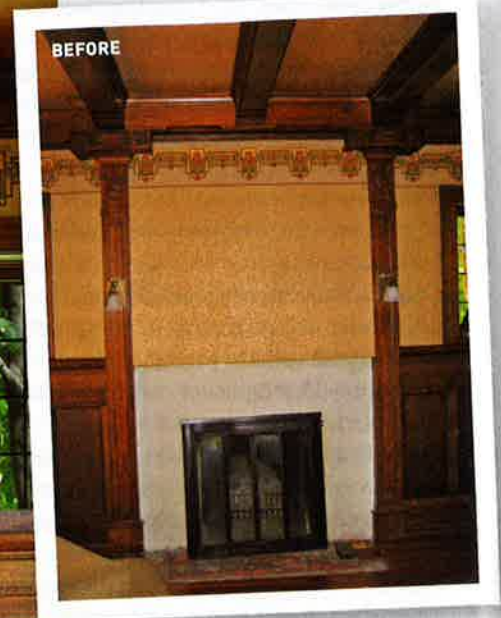
Restored to glory—with original bricks in the surround. A new overmantel took the place of damaged bricks under later drywall. The bas-relief panel was found under the drywall.

The challenge was what to do about the lack of bricks for the upper wall. David Heide designed a new overmantel in white oak, which frames the plaster frieze panel. He took cues from what remained, working out the proportions of everything from the projection of the mantel shelf (an outline was still visible on the sides of the pilasters), to the design of decorative corbels and the stickwork and stylized motifs. The cabinetmakers then replicated these elements—their work is top-notch.

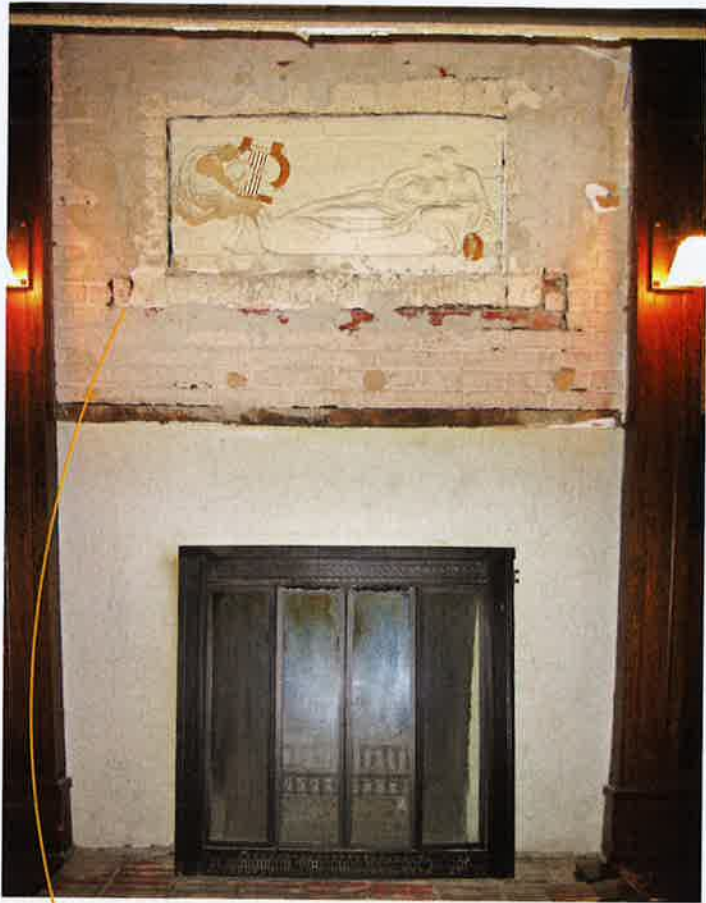
**CLOCKWISE, FROM TOP LEFT:** Behind the drywall, the owners found a classical bas-relief panel. The cabinetmaker created a new overmantel treatment and reconfigured the pilasters to accommodate vintage sconces, which now illuminate the sculpted frieze. Conserved and repaired, the panel is framed by the woodwork.

**When we bought our house** in St. Paul's West Summit Avenue Historic District, it was a bank-owned foreclosure property with no heat and burst pipes. Unique details were intact, though, so we were happy to undertake its restoration. We knew immediately that the parlor fireplace needed help; it was an eyesore in an otherwise pristine room fitted with quarter-sawn white oak panels, beams, and columns. It had been modernized at some low point in its century of survival: A panel of Sheetrock had been glued to the brick between two original wood pilasters, supported by plaster slathered over the brick in the firebox surround. We discovered, behind the drywall, a classical bas-relief plaster panel labeled "Homer."
