PROJECT PROFILE

Dayton's Bluff Victorian

Project Type: Exterior Reconstruction

Location: St. Paul

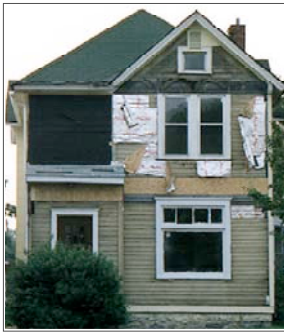
BEFORE

Located in Historic Dayton's Bluff, this simple Stick-Style Victorian had lost nearly all of its original decorative features, including the entire front porch. A survey of the neighborhood yielded information about how porches of similar buildings had been configured. Further investigation revealed four original footings which defined the foot-print of the reconstructed porch.

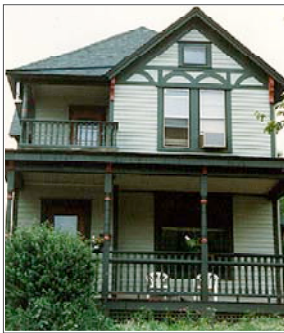
AFTER

Built upon these original piers, the new wood porch is composed of turned columns and balusters. The spindle valance and a double top rail acknowledge both an earlier height while complying with current code.

Further investigative demolition suggested that a second-floor, windowless bathroom over the front door hadn't always been there. As the floor and walls were removed, it became clear that the room was the former site of an upper-level porch. Now restored, this small perch affords spectacular views of the river valley beyond. The building has been painted in period-appropriate colors, and design was developed within the guidelines of the local Heritage Preservation district.
