# Everyday solutions

## A restored fireplace brings historic flair back to a century-old living room.

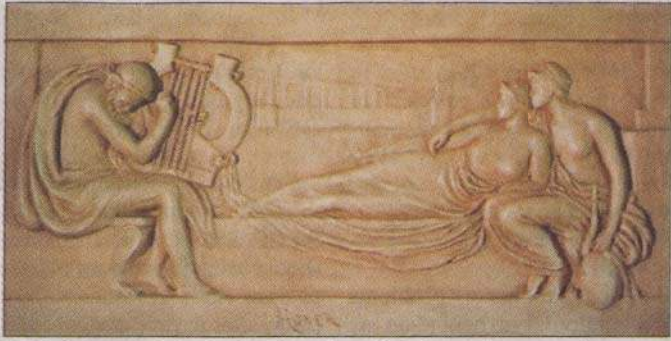
A fabricator used the design found in a historic catalog as a guide.

Nelson enlisted a St. Paul fabricator to restore the antique panel, depicting a scene from Greek mythology. "The fabricator found the actual piece in one of their historic catalogs for \$5," said Nelson. "They were able to reproduce it, using that image."

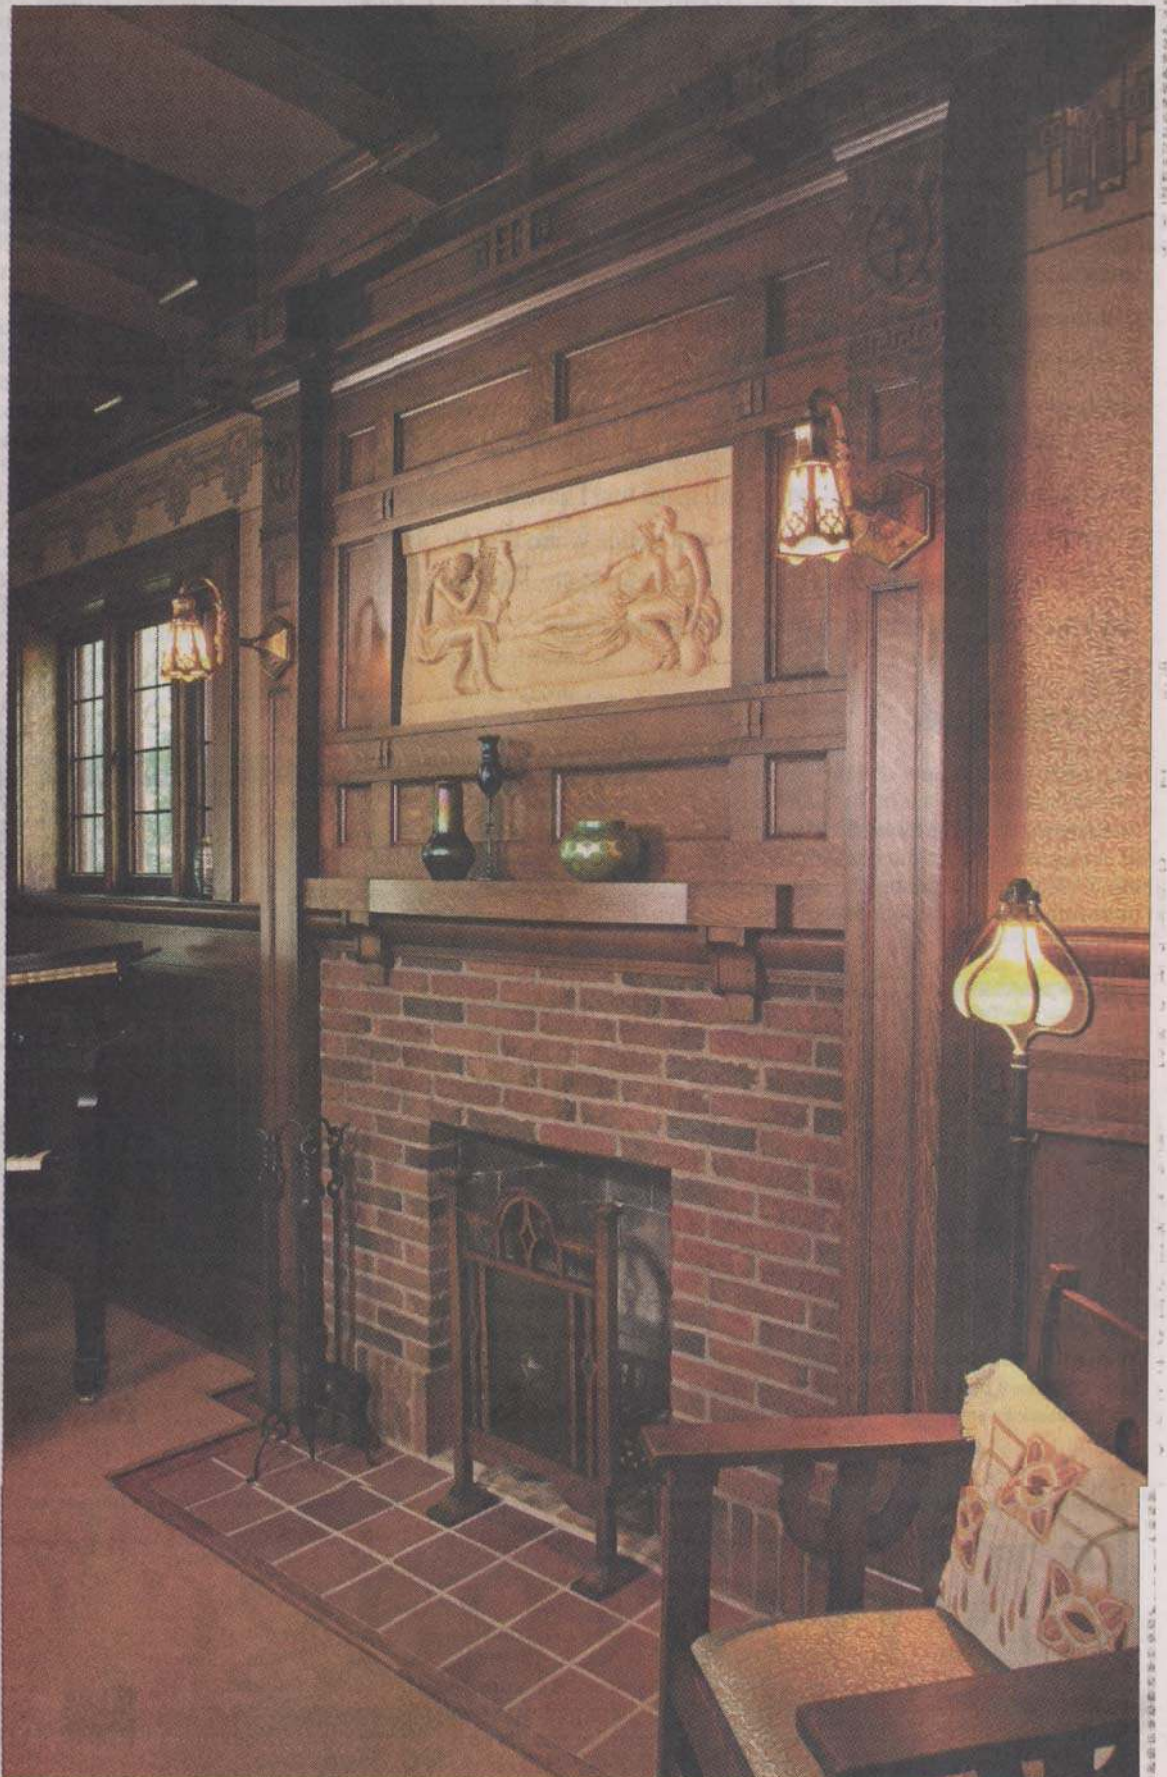
Mark Nelson took cues from other rooms to design a fireplace that looks like it was always part of the 1912 home.

mantel spanning the original pilasters, as well as oak paneling to frame the bas relief artwork. "It was inspired by the heavily detailed cabinetry and casework in the rest of the house," said Nelson.

**Stylish surround:** Since there wasn't enough salvageable brick for the top part of the fireplace, Belka designed a quartersawn white oak

**Historic hearth:** After they removed the marble slab, "we could see the imprint of the original hearth tile," said Nelson. "We put in red quarry tile that matches the tile in the front porch of the house."

**Period lighting:** Gjerde found antique brass sconces on eBay that are similar to original fixtures in the house. They were rewired and restored and positioned higher on the pilasters to highlight the bas relief.

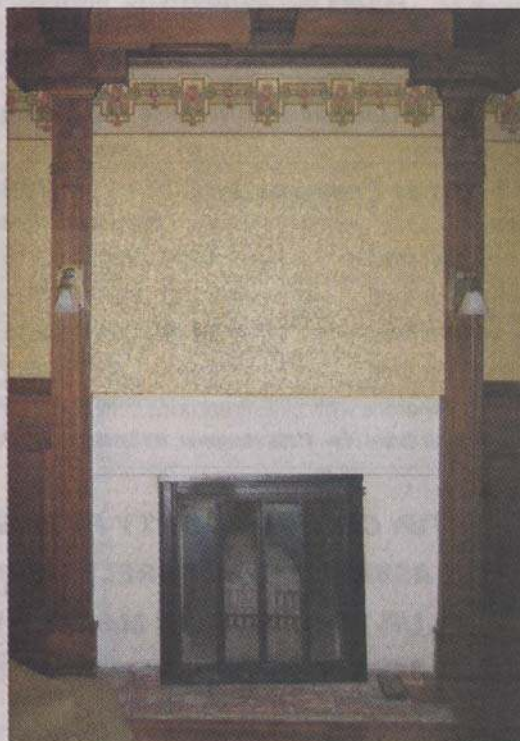
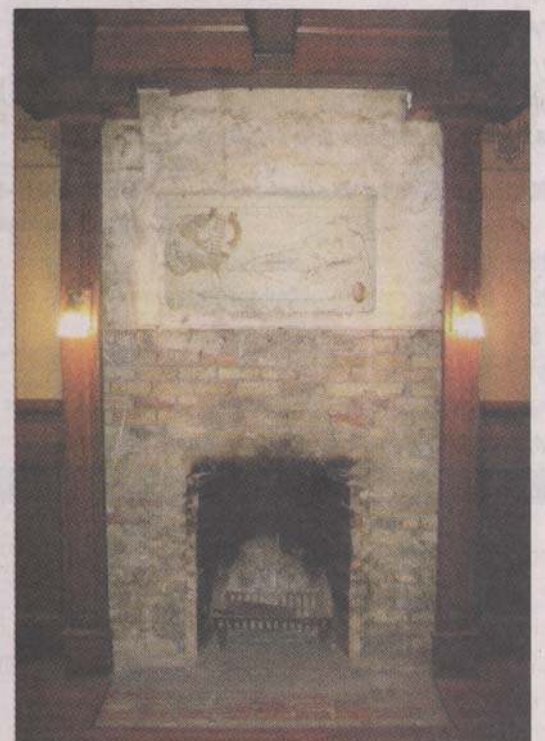
**BEFORE:** Demolition of the existing fireplace's drywall and marble slab, left, revealed the original brick facade and plaster bas relief panel, right.

**Buried treasure:** Gjerde pried off a piece of wallboard with a crowbar and uncovered a plaster bas relief panel above the fireplace. It was damaged, chipped and had been painted gold. "We were excited, because it looked original," said Gjerde.

**Fireplace facelift:** When Nelson's crew tore off all the marble and wallboard, they discovered the original floor-to-ceiling brick facade. Many of the bricks were damaged. "The mason came up with the bright idea to remove the bricks, turn them around and expose the back side," said Nelson. "But it was quite an effort to take it all out, clean it and place it all back together."
