star tribune/aia everyday solutions

Everyday solutions

A restored fireplace brings historic flair back to a century-old living room.

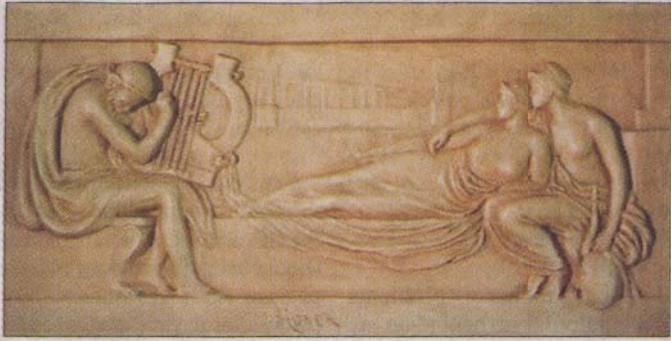
A fabricator used the design found in a historic catalog as a guide.

Nelson enlisted a St. Paul fabricator to restore the antique panel, depicting a scene from Greek mythology. "The fabricator found the actual piece in one of their historic catalogs for \$5," said Nelson. "They were able to reproduce it, using that image."

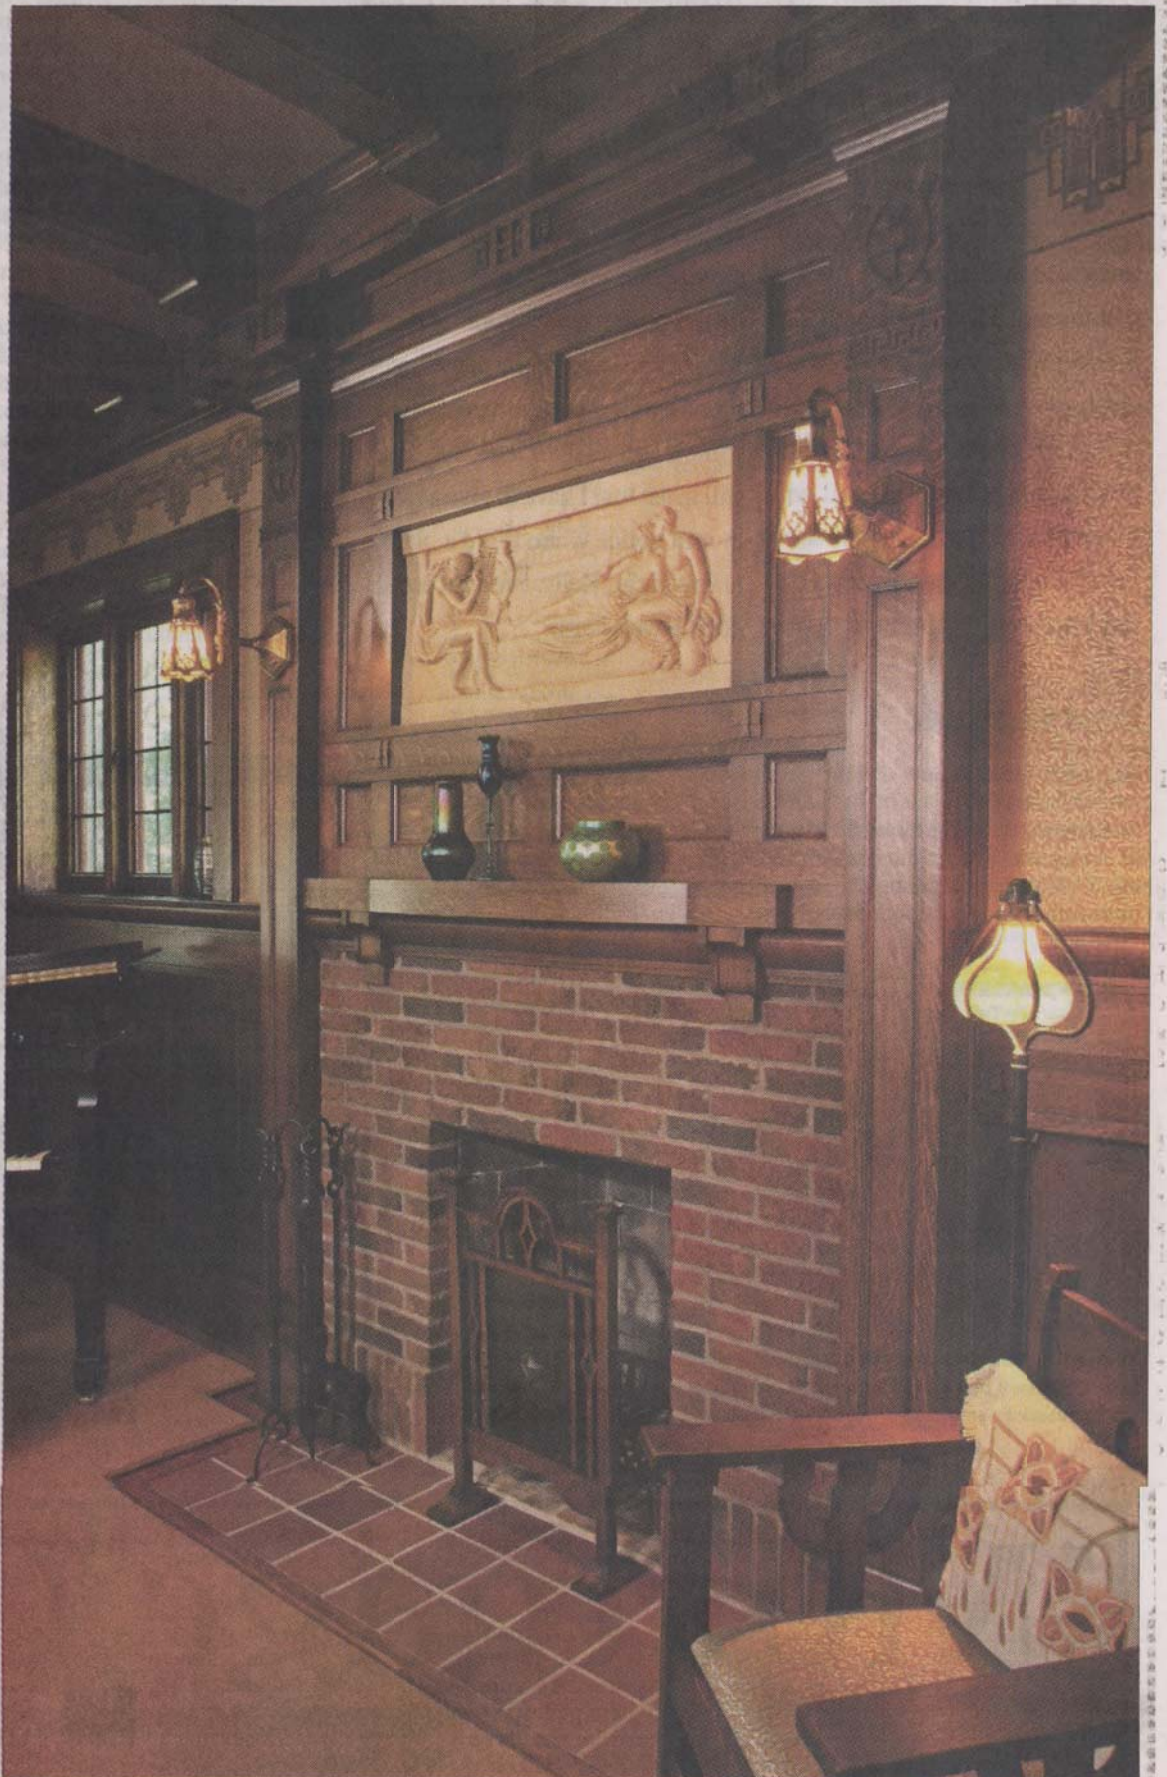
Mark Nelson took cues from other rooms to design a fireplace that looks like it was always part of the 1912 home.

mantel spanning the original pilasters, as well as oak paneling to frame the bas relief artwork. "It was inspired by the heavily detailed cabinetry and casework in the rest of the house," said Nelson.

Stylish surround: Since there wasn't enough salvageable brick for the top part of the fireplace, Belka designed a quartersawn white oak

Historic hearth: After they removed the marble slab, "we could see the imprint of the original hearth tile," said Nelson. "We put in red quarry tile that matches the tile in the front porch of the house."

Period lighting: Gjerde found antique brass sconces on eBay that are similar to original fixtures in the house. They were rewired and restored and positioned higher on the pilasters to highlight the bas relief.

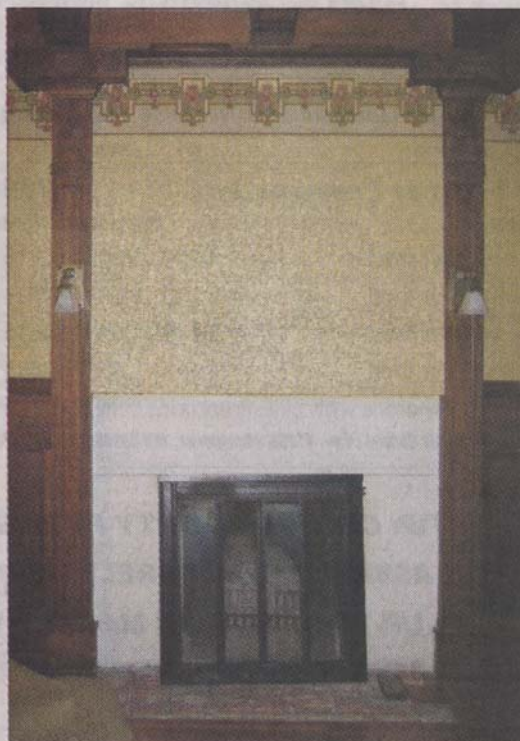
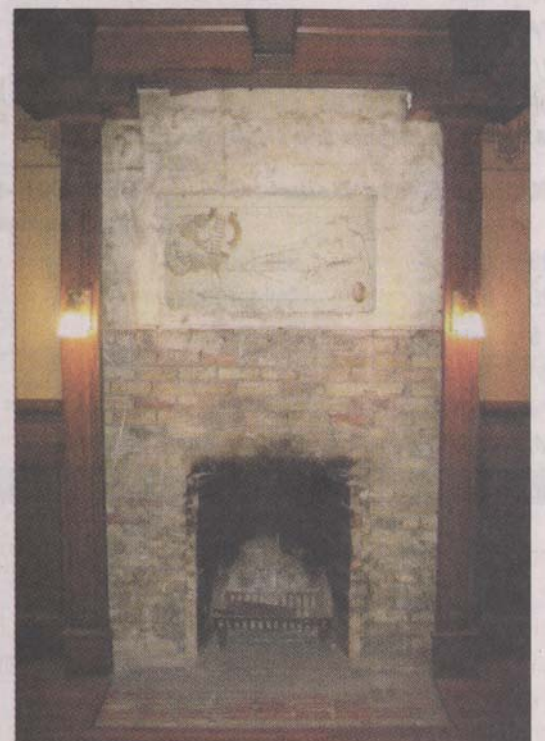
BEFORE: Demolition of the existing fireplace's drywall and marble slab, left, revealed the original brick facade and plaster bas relief panel, right.

Buried treasure: Gjerde pried off a piece of wallboard with a crowbar and uncovered a plaster bas relief panel above the fireplace. It was damaged, chipped and had been painted gold. "We were excited, because it looked original," said Gjerde.

Fireplace facelift: When Nelson's crew tore off all the marble and wallboard, they discovered the original floor-to-ceiling brick facade. Many of the bricks were damaged. "The mason came up with the bright idea to remove the bricks, turn them around and expose the back side," said Nelson. "But it was quite an effort to take it all out, clean it and place it all back together."
